| <b>TSB</b> | <b>Model</b> | OPTIMA(TF) (ALL) |
| | <b>TSB No.</b> | KFE12-92-P020-TF |
| <b>Subject</b><br><b>OPTIMA (TF) AUDIO DISPLAY MALFUNCTION REPAIR</b> | <b>TSB Type</b> | Field Fix |

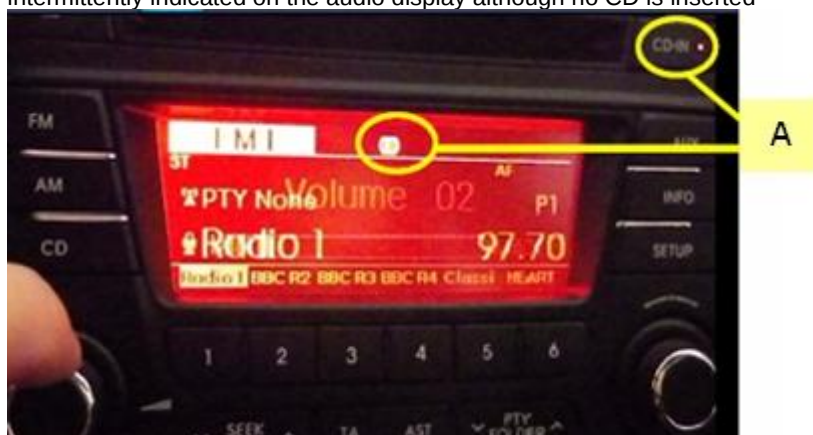
On some Optima (TF) RHD vehicles equipped with CD player audio the “CD-IN” icon (A) might be intermittently indicated on the audio display although no CD is inserted

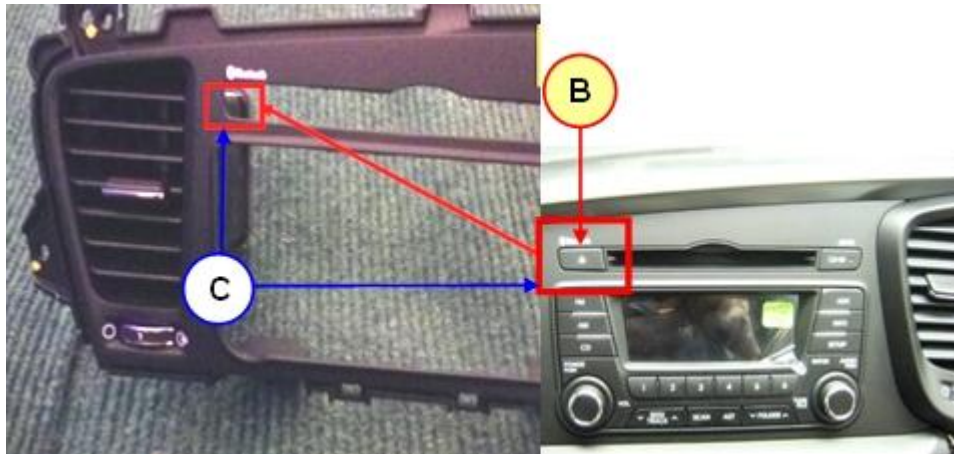
The eject button (B) does not return completely due to the interference with the center fascia upper panel (C).

Only for the vehicle exhibiting the condition mentioned above cut the interference part of the center fascia upper panel following the Service Procedure to repair this concern.
