## BACK WARNING SYSTEM

## BACK WARNING CONTROL MODULE

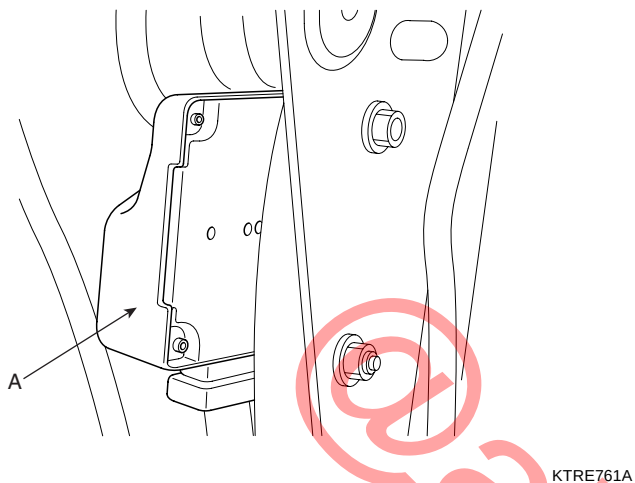
1. Remove the right quarter trim of the trunk (Refer to the Interior trim in the BD group.)
2. Loosen the mounting nuts (2EA) and remove the back warning control unit (A) from the quarter panel.
